U.S. Department
of Transportation
**Federal Aviation
Administration**

General Aviation Airworthiness Alerts

AC No. 43-16

**ALERT NO. 223
FEBRUARY 1997**

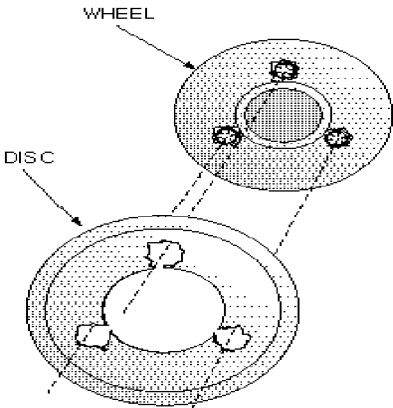
The right wheel brake failed while the aircraft was taxiing to the parking ramp.

An inspection disclosed the brake disk (P/N 164-32505) was torn off of the wheel assembly. (Refer to the following illustration.) The attachment bolts were intact, and part of the brake disk was still secure under them. The brake disk was manufactured by Cleveland. The submitter stated this was the second occurrence of this defect on the same aircraft. The other failure occurred on December 26, 1995, with a total operating time of 1,617 hours. It was speculated this defect could have been caused by "improper alloy castings or by cracks around bolt holes."

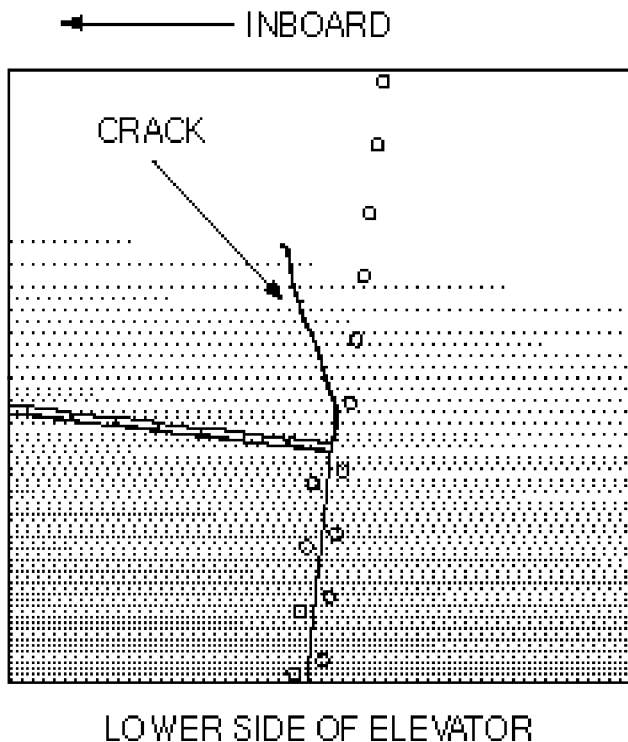
A crack was found in the left elevator skin during a scheduled inspection.

The crack appeared to originate at the trailing edge of the forward skin and began at the outboard corner of the trim tab cutout. The crack was approximately 4 inches long. (Refer to the following illustration.) The submitter offered three possible causes for this defect.

1. The trim tab actuating mechanism was excessively loose; however, the mechanism was no more loose than is commonly found on most aircraft of this model.
2. Oil canning of the skin.
3. Aft center-of-gravity (CG) loading. Aft CG loading reduces the aerodynamic loading of the elevator and trim tab, this combined with a loose trim tab, and oil canning could have induced a buzz or flutter which resulted in a crack.

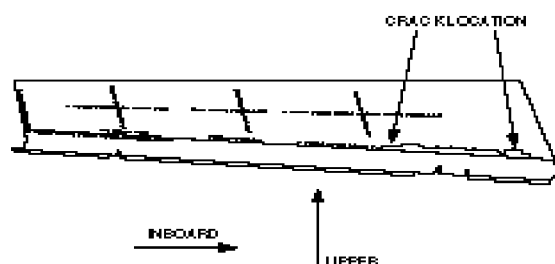
Reports of cracking in the upper surface of the ailerons on these models indicate a possible systemic problem. Most of the reported cracks have been located on the right aileron, which does not have a trim tab. (Refer to the following illustration for crack location and orientation.) The exact location and orientation of the cracks varied from one case to the next. Although, they were generally found in the upper skin just above the aileron drive mechanism.

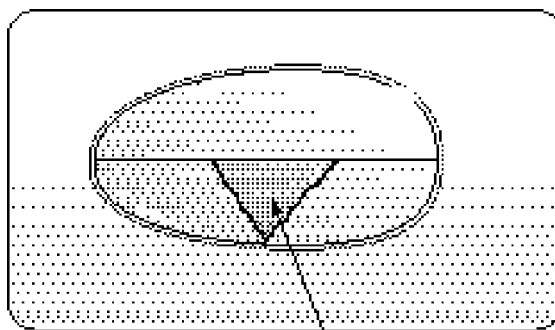
MISSING SECTION

The pilot reported hearing an abnormal noise during flight.

An inspection of the aircraft revealed the right rear baggage compartment window (P/N 101-440042-4) was broken, and a section was missing. (Refer to the following illustration.) The submitter could not determine the cause of this failure, and the age of the window was not reported. Small flaws can progress to the point of failure if not corrected. It would be wise to pay close attention to this area during scheduled inspections and maintenance.

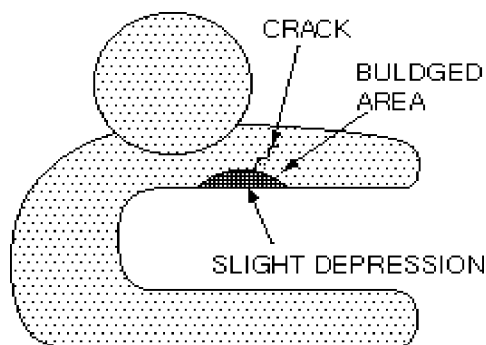
A slight depression was found in the nose landing gear uplock hook during a scheduled inspection.

The area on the side of the uplock hook assembly (P/N 122-820032-1) was bulged, and the depression was located at the point where the uplock roller strikes. (Refer to the following illustration.) The uplock assembly was removed. A crack was found originating from the center of the depression. Any wear or depression found on the uplock hook should be thoroughly investigated.

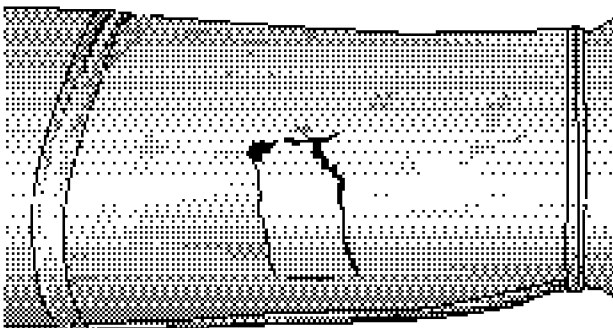
An engine exhaust stain was noticed by the pilot during a preflight inspection, and maintenance personnel were summoned.

An inspection revealed a large crack in the upper surface of the engine exhaust duct (P/N 2654018-18). (Refer to the following illustration.) It was necessary to replace the exhaust duct. It was recommended this part be closely inspected during scheduled inspections and maintenance.

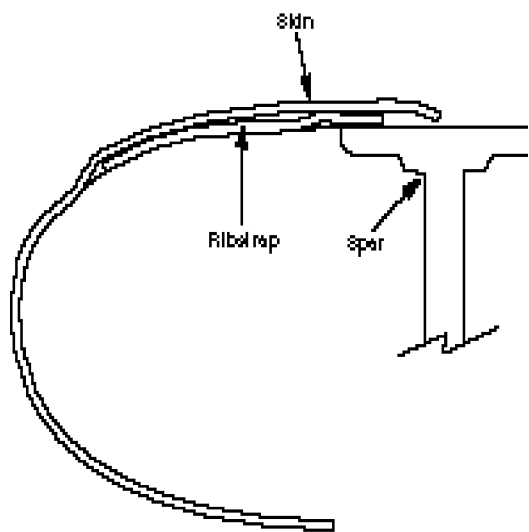
A “bump,” measuring approximately .050 inch, was found in the left wing skin at Wing Station (WS) 91.

Further inspection disclosed the wing rib upper strap (P/N 5522620) was joggled to fit between the spar and the rib. When the assembly was completed at the factory, the strap was apparently installed above the spar. (Refer to the following illustration.) This extra thickness created the “bump” in the skin. The manufacturer could offer no reason for this defect. The submitter suggested that all operators of like aircraft inspect the aircraft for this condition.

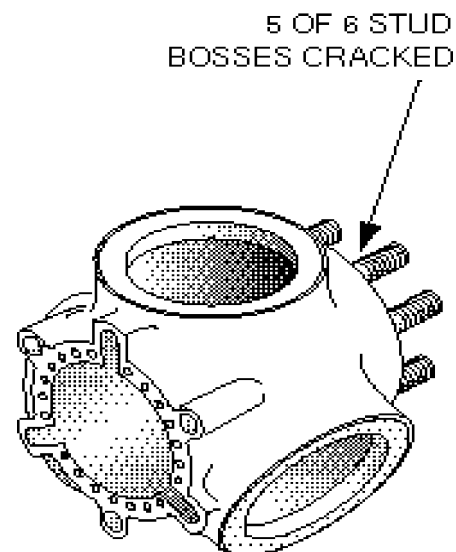
During an annual inspection, the maintenance technician discovered the propeller hub was cracked.

The propeller hub was cracked adjacent to five of the six mounting studs. (Refer to the following illustration.) The propeller had accumulated approximately 40 hours of operating time since the last overhaul, which was done in January 1996.
